Written Fuel Summary Report

**Tank 1 -Off Bottom**

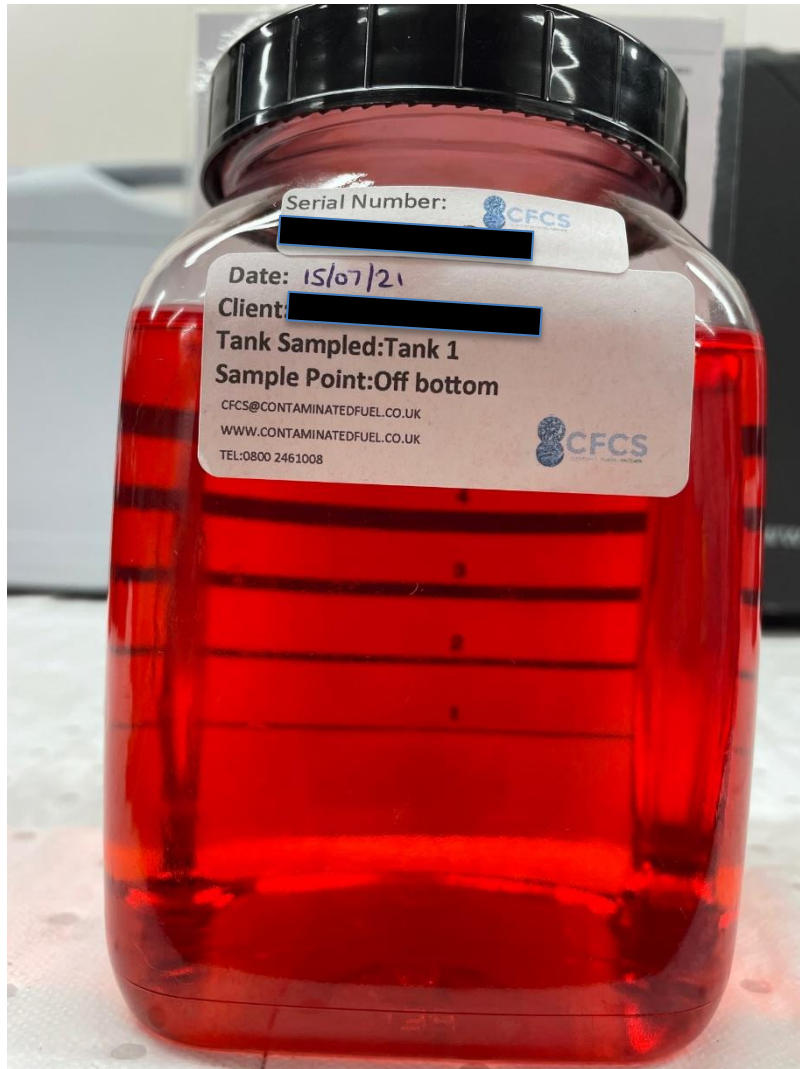
Clear and Bright to ASTM D4176, no free water, no debris, no MBG, moisture content <200PPM, ISO 4406 17/15/10, flashpoint >55, FAME 0.06%, cetane 48.9, density 826, ATP Test 0 RLU's, DCI 51.85, cloudpoint -5.8.

**Fuel is within specification on tests performed.**

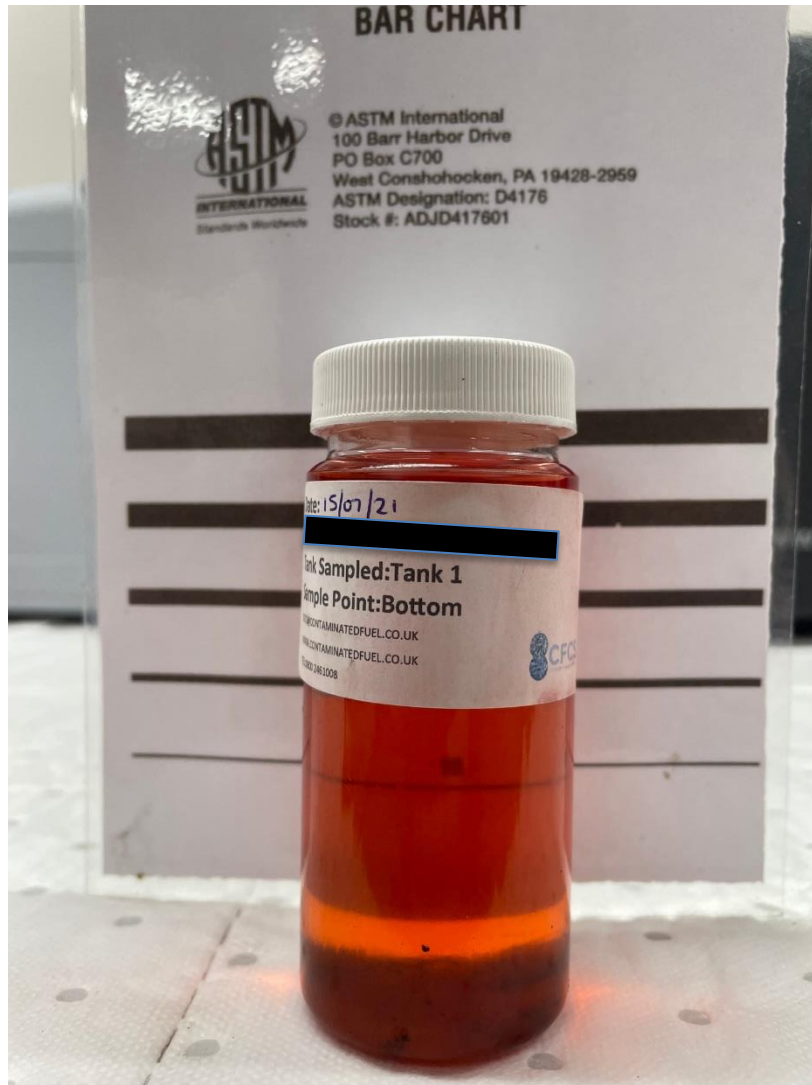
A Bottom sample was obtained from the tank as a reference. A picture of these can be seen below.

Sample has traces of debris and MBG present. An additional ATP test was performed which gave a reading of 2 RLU's.
